SUBJECT: Site Inspection, Wes Hansen, Quality Building Stone, Unpermitted Quarry, M/055/022, Wayne County, Utah

Date of Inspection: January 30, 2004
Time of Inspection: About 11:05 to 11:15 a.m. and 4:00 to 4:45 p.m.
Conditions: Mostly cloudy, 40's
Participants: Will Stokes (SITLA), Buzz Rakow (BLM), and Paul Baker (DOGM) in the morning; just Paul Baker in the afternoon

ATTACHMENT
Photographs
M/055/022, Quality Building Stone
Inspection Dated: January 30, 2004; Report Dated: February 24, 2004

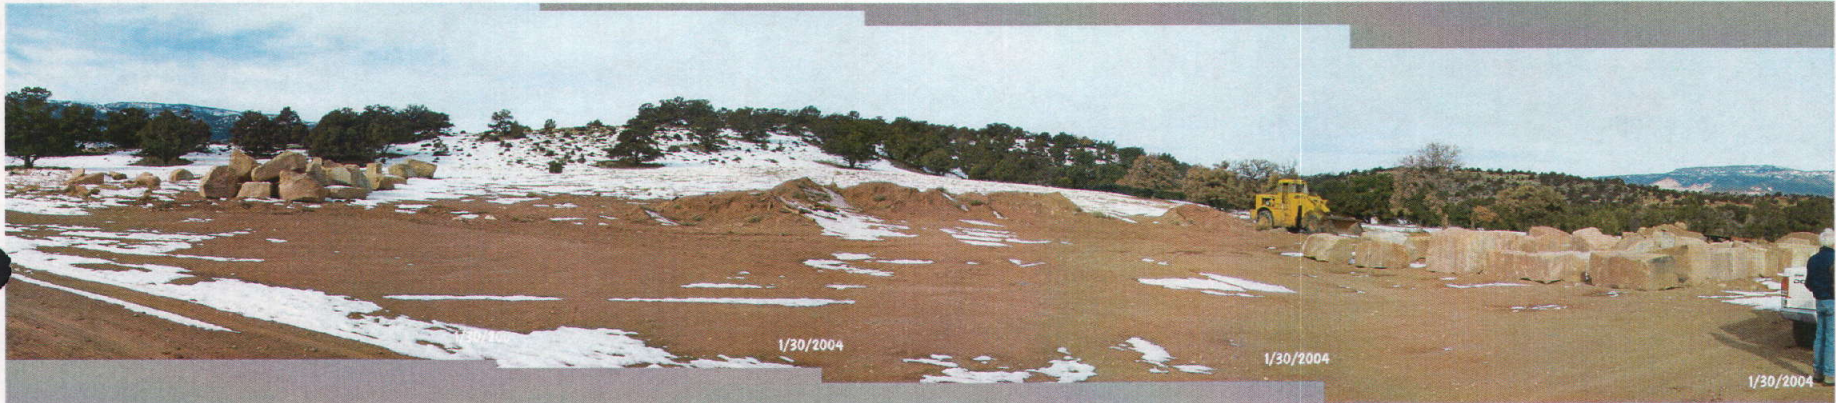
The loadout is shown in Photo 1. The area is basically flat with several stone blocks lying around. There are some soil berms, but it appears they were created to make the area more flat rather than in an attempt to salvage soil.

Photo 1. Panorama of the loadout area. From left to right, the photo show views looking southwest to northwest.

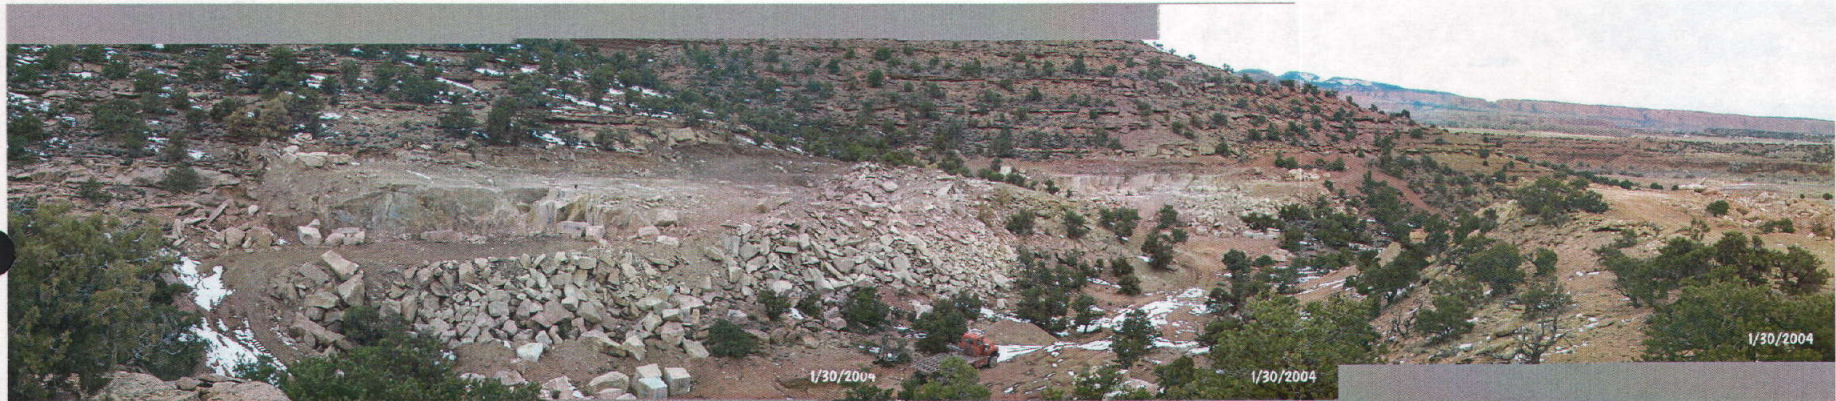
Photo 2 is a panorama composite of four pictures in the main quarry area. This picture was taken from the "South end of quarry" point shown on the map and basically rotates from west (left) to north. Most of the quarry is within or adjacent to the drainage shown in this picture, but parts of the quarry are farther south (Photo 5) and in a drainage to the east (Photo 6). (Please note that although these photos indicate they were taken January 1, 1999, they were actually taken during this inspection on January 30, 2004. I changed the camera batteries and forgot to change the date setting.)

Photo 2. Panorama of part of the quarry area. The left side of the photo is approximately west, and the right is approximately north.

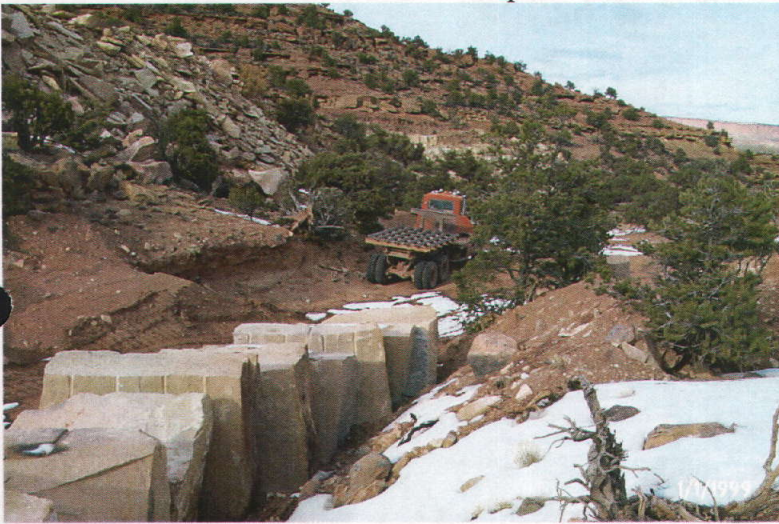
There are two places where stone, waste material, overburden, a road, or equipment has been placed in drainages. These are shown in Photos 3 and 4.

Photo 3. Cut stones, a road, and a truck in the main drainage.

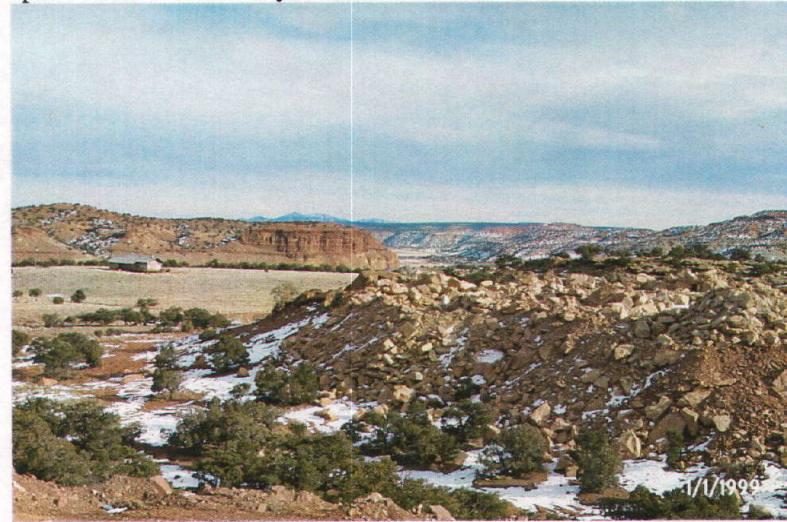
Photo 5. Some of the disturbance in the northeast part of the area.

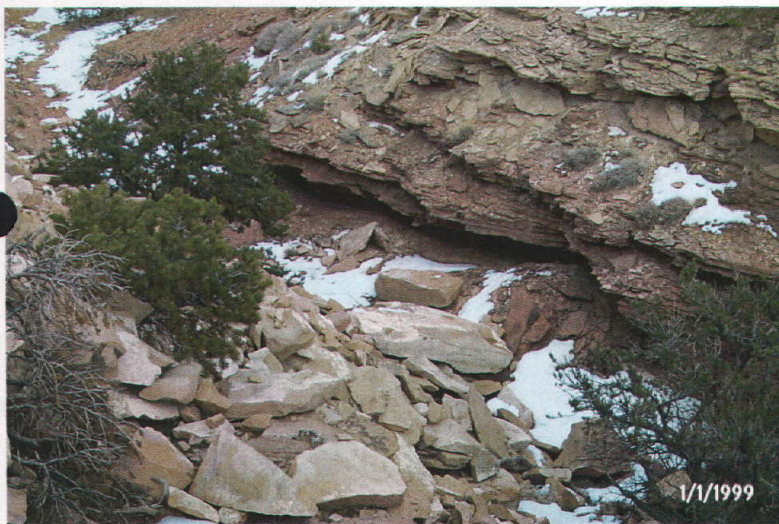
Photo 4. Overburden or waste in a drainage east of the main drainage in Photo 3.

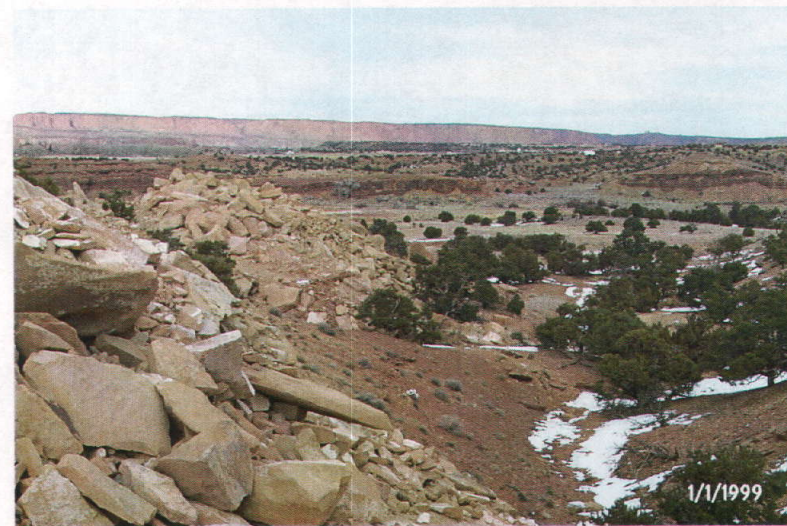
Photo 6. Farther north in the drainage shown in Photo 4.

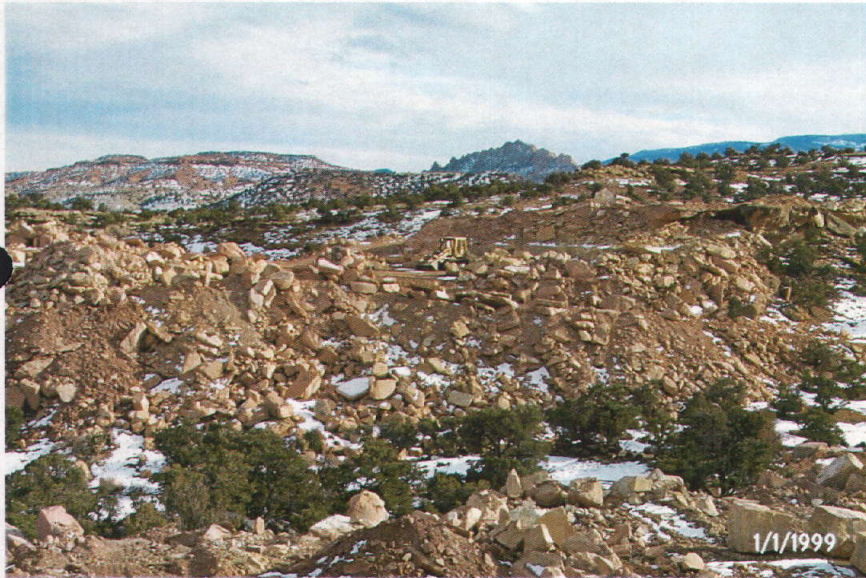
Photo 7 is a picture looking approximately southeast from the northwest portion of the quarry.

Photo 7. Looking approximately southeast toward the point from which the panorama in Photo 2 was taken.
